**Flood Control Project Maintenance  
Levee Inspections**  
**LMA District Cover Sheet**  
**Spring 2019 Levee Inspection Results**

**Reclamation District No. 0501 Ryer Island**

**Spring 2019 Levee Inspection Results**

**Levee Inspection Report By Mile - Spring 2019**

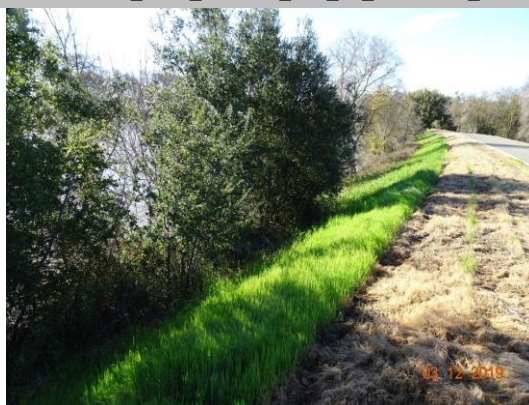
Photo 1 of 1 : SP\_2019\_RD0501\_169\_24\_20190314\_00066.jpg

LM Start	0.11	Rating **	M	Issue No.	24
LM End	0.11	Issue Type +	Ma	Location *	WS
Category	Earthen Levee			GPS Latitude/Longitude	
				Start	End
Item	Trim / Thin Trees			38.253217 °	38.253217 °
				-121.602480 °	-121.602480 °
DWR ID	DWR_RD0501_01_s_2019_24				
Comment Code					
T1 : Trim trees to at least five feet above ground level.					
Inspector Comment					
Trim trees within 20 feet of the crown.

View looking downstream at trees within 20' of the levee crown (Spring 2019).

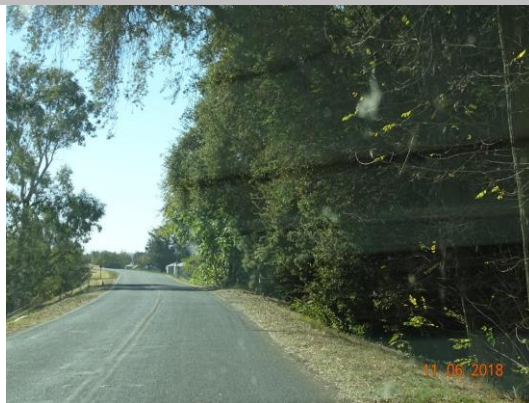
Photo 1 of 1 : SP\_2019\_RD0501\_169\_44\_20190311\_00011.jpg

LM Start	0.22	Rating **	M	Issue No.	44
LM End	0.28	Issue Type +	En	Location *	LS
Category	Earthen Levee			GPS Latitude/Longitude	
				Start	End
Item	Vegetation			38.251598 °	38.250730 °
				-121.603068 °	-121.603190 °
DWR ID	DWR_RD0501_01_f_2018_44				
Comment Code					
V6 : Landscaping					
Inspector Comment					
Landscaping trees are obstructing view down the landside slope.

View looking downstream at landscaping trees on the landside slope (November 2018).

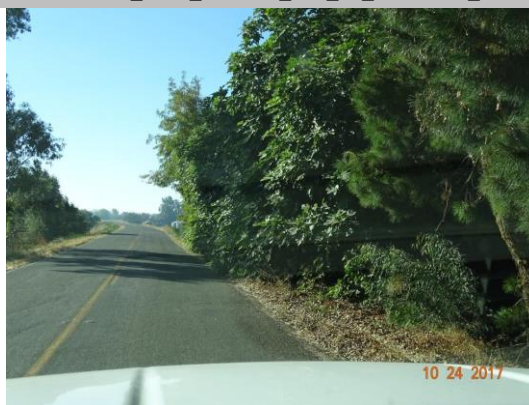
Photo 1 of 1 : SP\_2019\_RD0501\_169\_27\_20190311\_00003.jpg

LM Start	0.28	Rating **	M	Issue No.	27
LM End	0.28	Issue Type +	En	Location *	LS
Category	Earthen Levee			GPS Latitude/Longitude	
				Start	End
Item	Vegetation			38.250809 °	38.250809 °
				-121.603119 °	-121.603119 °
DWR ID	DWR_RD0501_01_f_2017_27				
Comment Code					
V6 : Landscaping					
Inspector Comment					
Trim fig trees to allow inspection and access to landside slope and toe.

View of fig trees on the landside slope and toe.

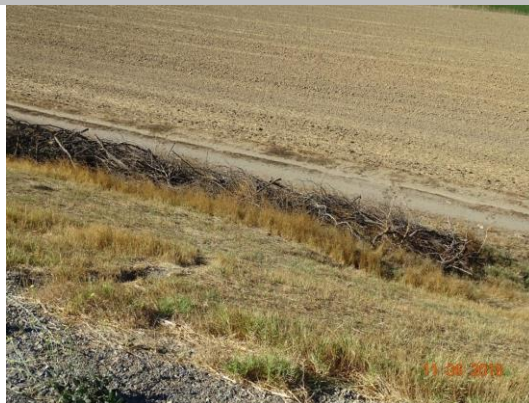
Photo 1 of 1 : SP\_2019\_RD0501\_169\_45\_20190311\_00012.jpg

LM Start	0.47	Rating **	M	Issue No.	45
LM End	0.47	Issue Type +	En	Location *	LS
Category	Earthen Levee			GPS Latitude/Longitude	
				Start	End
Item	Encroachments			38.247957 °	38.247957 °
				-121.602965 °	-121.602965 °
DWR ID	DWR_RD0501_01_f_2018_45				
Comment Code					
PR : Prunings					
Inspector Comment					
Remove prunings from the landside toe.

View of prunings on the landside toe (November 2018).

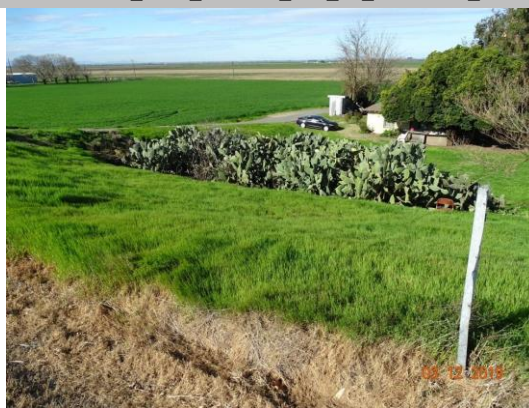
Photo 1 of 1 : SP\_2019\_RD0501\_169\_28\_20190314\_00067.jpg

LM Start	0.57	Rating **	M	Issue No.	28
LM End	0.57	Issue Type +	En	Location *	LS
Category	Earthen Levee			GPS Latitude/Longitude	
				Start	End
Item	Vegetation			38.246590 °	38.246590 °
				-121.602833 °	-121.602833 °
DWR ID	DWR_RD0501_01_s_2019_28				
Comment Code					
V6 : Landscaping					
Inspector Comment					
Remove cactus on the landside toe.

View of cactus on the landside toe (Spring 2019).

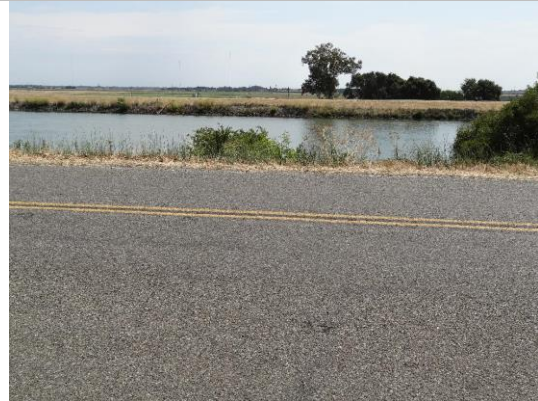
Photo 2 of 3 : UCIP\_SP\_2019\_50020\_75647.jpg

Comment Code					
Inspector Comment					
FS_ID:50020 DS_ID:21034 EP_NO: N/A Repair Type: Non-Urgent Crossing Status: Found UCIP Comments: 8/22/2016 Crossing has been downgraded from Urgent to Non-Urgent -- no evidence of damage to levee is present. Dense vegetation limits the inspector's visibility to identify signs of pipe failure (leaks) through the slope. Recommend removing vegetation along pipe alignment to conduct proper inspection of structure and appurtenances. Also will need to coordinate with owner to determine if permit was obtained for the modifications made to crossing (PVC pipe sleeved through existing pipe). (DWR UCIP - omagana)4/21/2015 Unauthorized PVC pipe. Annular space not grouted. 14-inch pipe open on both ends. (DWR UCIP - omagana) FIELD_STRUCT_DESC: 14-inch steel irrigation siphon pipe through the levee, 3.2 feet below the crown. 10-inch polyvinyl chloride (PVC) pipe sleeved through the 14-inch pipe. Siphon breaker on the landside (LS) shoulder. [Additional Reference(s): DWR Levee Log, 2005. USACE Sacramento O&M Manual 105, April 1959, (HLM 1.0)]. FS Date: 8/22/2016

View of levee crown looking at waterside.

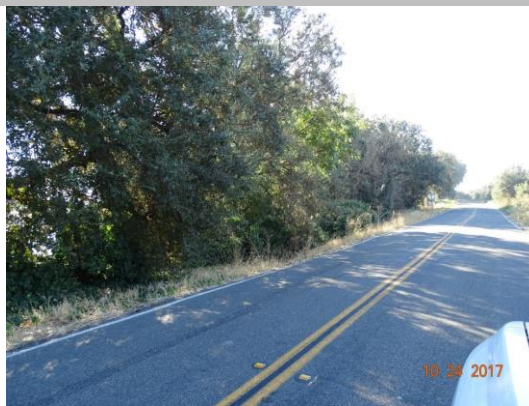
Photo 1 of 1 : SP\_2019\_RD0501\_169\_31\_20190311\_00006.jpg

LM Start	1.01	Rating **	M	Issue No.	31
LM End	1.11	Issue Type +	Ma	Location *	WS
Category	Earthen Levee			GPS Latitude/Longitude	
				Start	End
Item	Vegetation			38.240222 °	38.238918 °
				-121.603887 °	-121.604338 °
DWR ID	DWR_RD0501_01_f_2017_31				
Comment Code					
V2 : Remove the wild growth other than native grasses from the levee slopes.					
Inspector Comment					
Waterside vegetation should be thinned/removed to 20' from WS shoulder to allow inspection and access.

View of waterside vegetation.

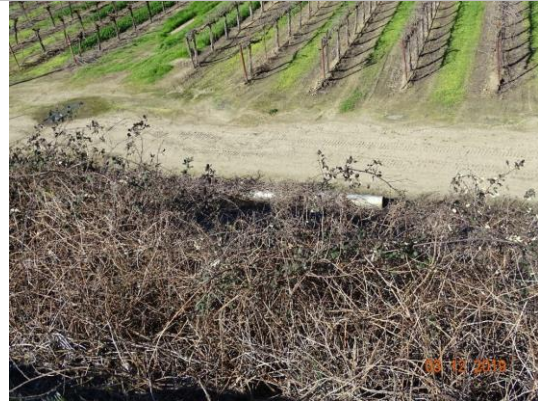
Photo 1 of 1 : SP\_2019\_RD0501\_169\_36\_20190314\_00069.jpg

LM Start	1.83	Rating **	M	Issue No.	36
LM End	1.83	Issue Type +	En	Location *	LS
Category	Earthen Levee			GPS Latitude/Longitude	
				Start	End
Item	Encroachments			38.228612 °	38.228612 °
				-121.604120 °	-121.604120 °
DWR ID	DWR_RD0501_01_s_2019_36				
Comment Code					
DE : Debris					
Inspector Comment					
Metal debris on the landside slope preventing LMA from completing vegetation maintenance on levee slope.

View of some of the metal debris on the landside toe (Spring 2019).

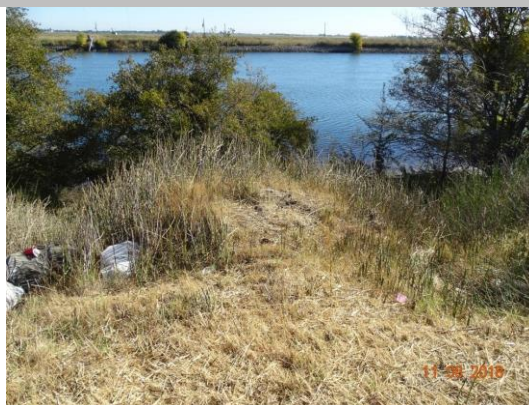
Photo 2 of 2 : SP\_2019\_RD0501\_169\_47\_20190311\_00014.jpg

LM Start	<b>2.07</b>	Rating **	U	Issue No.	<b>47 (cont)</b>
LM End	<b>2.07</b>	Issue Type +	Ma	Location *	WS

View of two additional foot paths that are more than 1 foot deep into the waterside slope (November 2018).

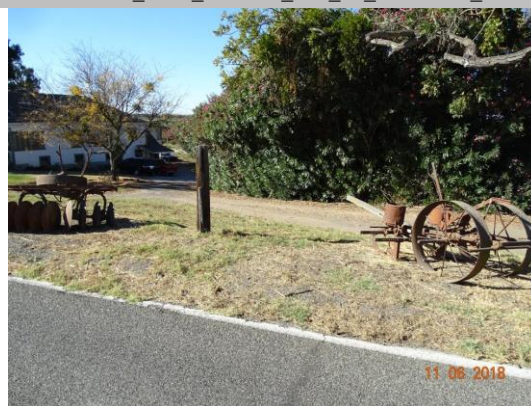
Photo 1 of 1 : SP\_2019\_RD0501\_169\_49\_20190311\_00015.jpg

LM Start	2.27	Rating **	M	Issue No.	49
LM End	2.27	Issue Type +	En	Location *	LS
Category	Earthen Levee			GPS Latitude/Longitude	
				Start	End
Item	Encroachments			38.222152 °	38.222152 °
				-121.603325 °	-121.603325 °
DWR ID	DWR_RD0501_01_f_2018_49				
Comment Code					
EQ : Equipment					
Inspector Comment

View of ornamental farm equipment on the landside shoulder (November 2018).

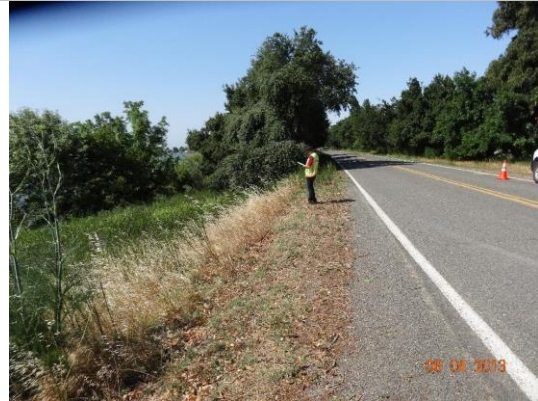
Photo 1 of 3 : UCIP\_SP\_2019\_32526\_58933.jpg

Overview of crown at crossing, looking downstream.

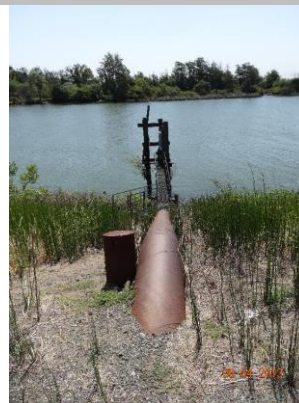
Photo 2 of 3 : UCIP\_SP\_2019\_32529\_58951.jpg

Comment Code						
Inspector Comment						
FS_ID:32529 DS_ID:21028 EP_NO: N/A Repair Type: Non-Urgent Crossing Status: Found UCIP Comments: Pipe was running during inspection. Crack on crown surface could be associated with pipe vibration during operation. Need to determine owner of crossing. Owner will need to clear vegetation along pipe alignment on landward side to prevent levee inspection along crossing. FIELD_STRUCT_DESC: 20-inch irrigation discharge pipe of an unknown material through the levee, 2.2 feet below the crown. 1.5-inch electrical conduit alongside the 20-inch pipe. Pump on a platform on the waterside (WS). Walkway present on the WS. Standpipe on the landside (LS) toe. Pipe exposed along both slopes. [Additional Reference(s): DWR Levee Log, 2005. USACE Sacramento O&M Manual 105, April 1959, (HLM 3.7)]. FS Date: 6/4/2013

View of waterward side--siphon breaker, walkway, platform, pump, and control panel.

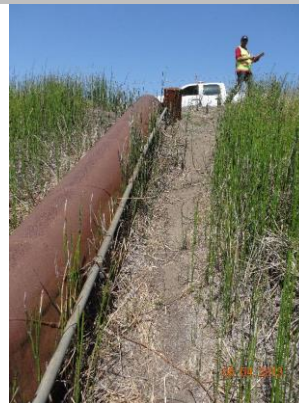
Photo 3 of 3 : UCIP\_SP\_2019\_32529\_58952.jpg

20-inch steel pipe along with 1.5-inch electrical conduit on landward side.

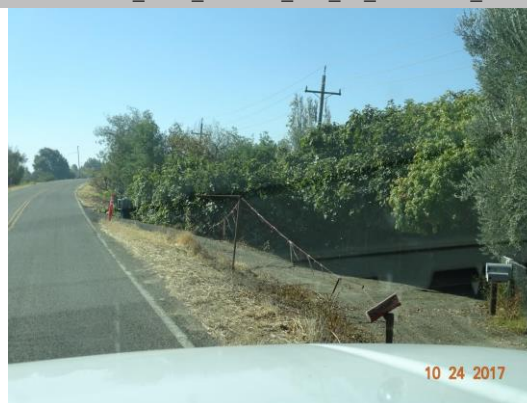
Photo 1 of 1 : SP\_2019\_RD0501\_169\_30\_20190311\_00005.jpg

LM Start	3.74	Rating **	M	Issue No.	30
LM End	3.74	Issue Type +	En	Location *	LS
Category	Earthen Levee			GPS Latitude/Longitude	
				Start	End
Item	Vegetation			38.202863 °	38.202863 °
				-121.613508 °	-121.613508 °
DWR ID	DWR_RD0501_01_f_2017_30				
Comment Code					
V6 : Landscaping					
Inspector Comment					
Landscaping should be thinned to allow inspection and access to slope and toe. Downed deadwood should also be removed from slope.

View of landscaping on slope and toe.

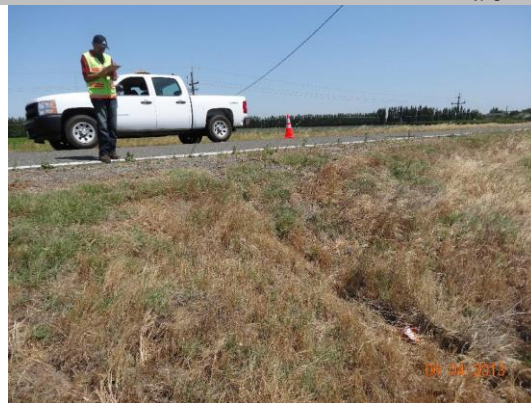
Photo 1 of 3 : UCIP\_SP\_2019\_19644\_33328.jpg

LM Start	<b>4.27</b>	Rating **	M	Issue No.	<b>157 (cont)</b>
LM End	<b>4.27</b>	Issue Type +	En	Location *

View of waterward side.

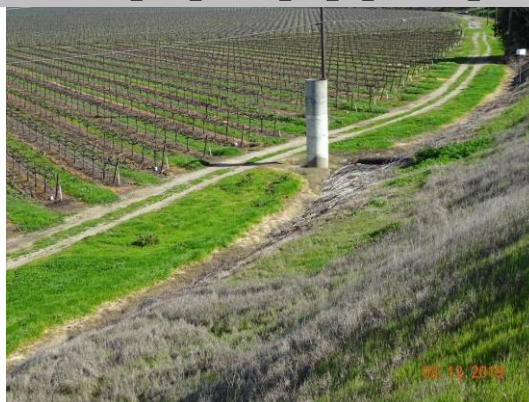
Photo 1 of 2 : SP\_2019\_RD0501\_169\_66\_20190314\_00071.jpg

LM Start	4.29	Rating **	M	Issue No.	66
LM End	4.41	Issue Type +	En	Location *	LS
Category	Earthen Levee			GPS Latitude/Longitude	
				Start	End
Item	Encroachments			38.195973 °	38.195167 °
				-121.618275 °	-121.620215 °
DWR ID	DWR_RD0501_01_s_2019_66				
Comment Code					
DT : Ditch					
Inspector Comment					
A ditch is located at the levee toe.

View looking upstream at ditch on the landside toe (Spring 2019).

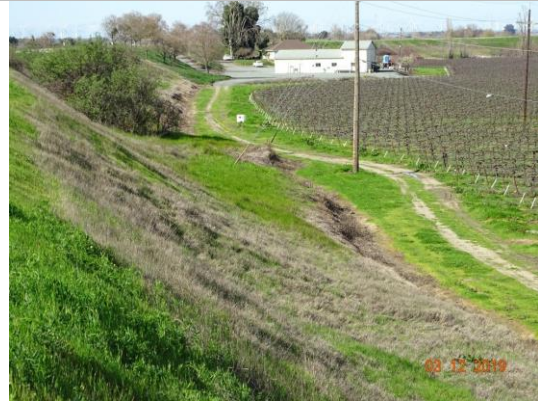
Photo 2 of 2 : SP\_2019\_RD0501\_169\_66\_20190314\_00072.jpg

LM Start	4.29	Rating **	M	Issue No.	66 (cont)	
LM End	4.41	Issue Type +	En	Location *	LS	
Category	Earthen Levee			GPS Latitude/Longitude		
				Start	End	
Item	Encroachments			38.195973 °	38.195167 °	
				-121.618275 °	-121.620215 °	
DWR ID	DWR_RD0501_01_s_2019_66					
Comment Code						
DT : Ditch						
Inspector Comment						
A ditch is located at the levee toe.

View looking downstream at ditch on the landside toe (Spring 2019).

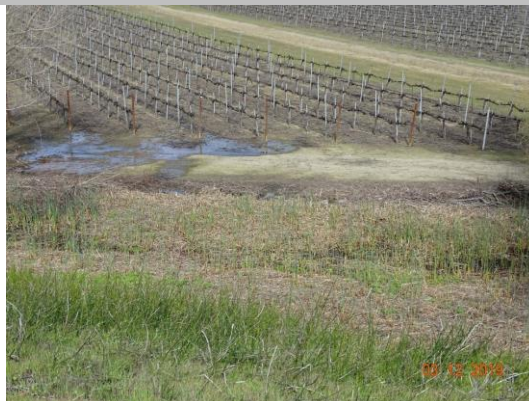
Photo 1 of 1 : SP\_2019\_RD0501\_169\_67\_20190314\_00074.jpg

LM Start	6.14	Rating **	U	Issue No.	67
LM End	6.14	Issue Type +	Ob	Location *	LS
Category	Earthen Levee			GPS Latitude/Longitude	
				Start	End
Item	Seepage / Sandboils			38.186135 °	38.186135 °
				-121.647902 °	-121.647902 °
DWR ID	DWR_RD0501_01_s_2019_67				
Comment Code					
Inspector Comment					
Evidence of seepage. Area dries out in summer and then returns with high water according to LMA. Tules growing. Water has an oily texture.

View of seepage at the landside toe due to Spring 2019 highwater (Spring 2019).

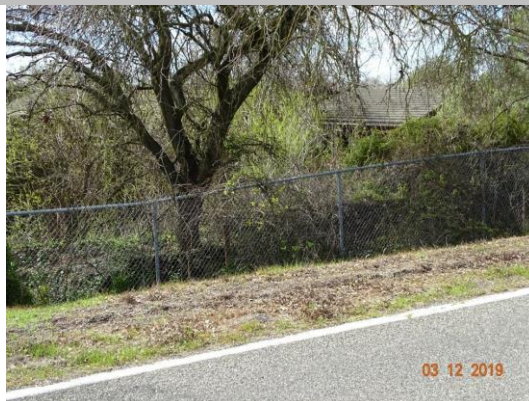
Photo 1 of 1 : SP\_2019\_RD0501\_169\_68\_20190314\_00075.jpg

LM Start	6.51	Rating **	M	Issue No.	68
LM End	6.64	Issue Type +	En	Location *	WS
Category	Earthen Levee			GPS Latitude/Longitude	
				Start	End
Item	Encroachments			38.184462 °	38.183758 °
				-121.654220 °	-121.656495 °
DWR ID	DWR_RD0501_01_s_2019_68				
Comment Code					
FE : Fence					
Inspector Comment					
A chainlink fence is located on the waterside slope.

View of chainlink fence on the waterside slope (Spring 2019).

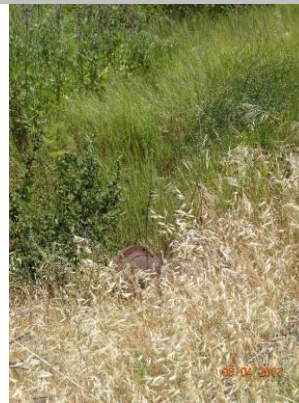
Photo 2 of 3 : UCIP\_SP\_2019\_32530\_58956.jpg

Overview of waterward side--section of pipe visible through dense vegetation.

Comment Code						
Inspector Comment						
FS_ID:32530 DS_ID:21020 EP_NO: N/A Repair Type: Non-Urgent Crossing Status: Found UCIP Comments: Dense vegetation limits the inspector's visibility to identify signs of pipe failure (leaks) through the slope. Recommend removing vegetation along pipe alignment to conduct proper inspection of structure and appurtenances. If structure is no longer used--Need to contact owner to determine status. If crossing is no longer used owner will need to coordinate with CVFPB. FIELD_STRUCT_DESC: *ABANDONED* 16-inch irrigation discharge pipe of an unknown material through the levee, 6.5 feet below the crown. Siphon breaker and service pole on the landside (LS) shoulder. Electrical box at the LS toe. Pump on a pile structure in the channel. 3-inch steel sewer pipe sleeved through 16-inch pipe. Annular space grouted. ([Additional Reference(s): DWR Levee Log, 2005]. FS Date: 6/4/2013

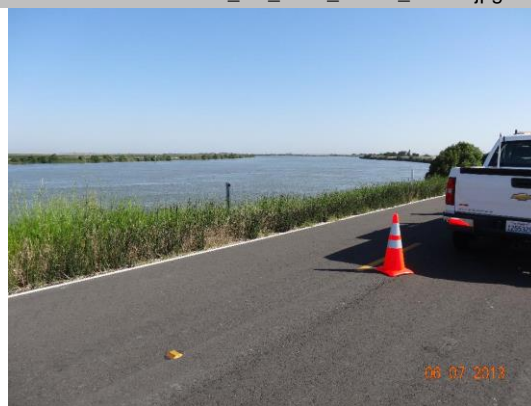
Photo 1 of 3 : UCIP\_SP\_2019\_32531\_58960.jpg

Comment Code					
Inspector Comment					
FS_ID:32531 DS_ID:21035 EP_NO: N/A Repair Type: Non-Urgent Crossing Status: Found UCIP Comments: Dense vegetation limits the inspector's visibility to identify signs of pipe failure (leaks) through the slope. Recommend removing vegetation along pipe alignment to conduct proper inspection of structure and appurtenances. Need to determine owner and status of crossing. FIELD_STRUCT_DESC: 10-inch irrigation discharge pipe of an unknown material sleeved through a 12-inch pipe of an unknown material through the levee, 5 feet below the crown. Pump on the waterside (WS). [Additional Reference(s): DWR Levee Log, 2005. USACE Sacramento O&M Manual 105, April 1959, (HLM 0.6)]. FS Date: 6/7/2013

View of crown.

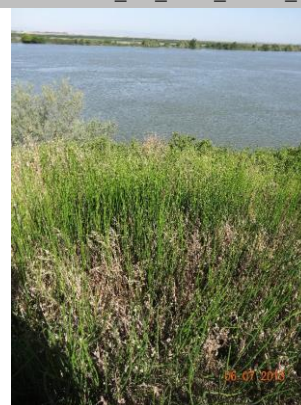
Photo 2 of 3 : UCIP\_SP\_2019\_32531\_58958.jpg

Overview of waterward side. Inaccessible due to dense vegetation.

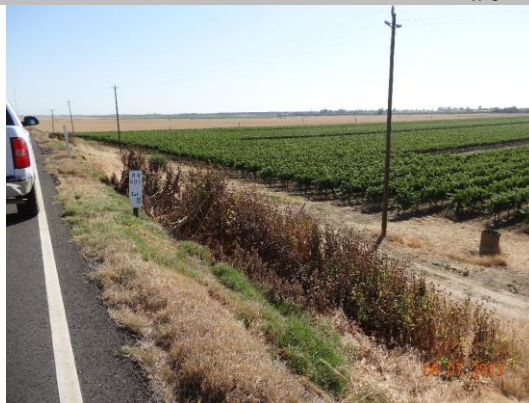
Photo 3 of 3 : UCIP\_SP\_2019\_32531\_58959.jpg

Comment Code						
Inspector Comment						
FS_ID:32531 DS_ID:21035 EP_NO: N/A Repair Type: Non-Urgent Crossing Status: Found UCIP Comments: Dense vegetation limits the inspector's visibility to identify signs of pipe failure (leaks) through the slope. Recommend removing vegetation along pipe alignment to conduct proper inspection of structure and appurtenances. Need to determine owner and status of crossing. FIELD_STRUCT_DESC: 10-inch irrigation discharge pipe of an unknown material sleeved through a 12-inch pipe of an unknown material through the levee, 5 feet below the crown. Pump on the waterside (WS). [Additional Reference(s): DWR Levee Log, 2005. USACE Sacramento O&M Manual 105, April 1959, (HLM 0.6)]. FS Date: 6/7/2013

Overview of landward side.

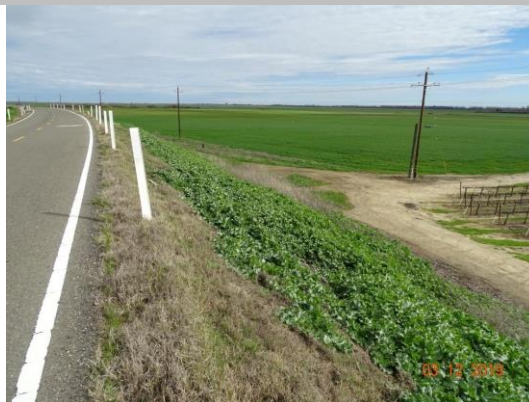
Photo 1 of 1 : SP\_2019\_RD0501\_170\_23\_20190314\_00044.jpg

LM Start	0.65	Rating **	M	Issue No.	23
LM End	0.75	Issue Type +	Ma	Location *	LS
Category	Earthen Levee			GPS Latitude/Longitude	
				Start	End
Item	Vegetation			38.192630 °	38.194068 °
				-121.655452 °	-121.655160 °
DWR ID	DWR_RD0501_02_s_2019_23				
Comment Code					
V1 : Control annual grass and weeds on the levee slopes and easements.					
Inspector Comment					
Remove annual vegetation from landside slope.

View looking upstream at vegetation on the landside slope (Spring 2019).

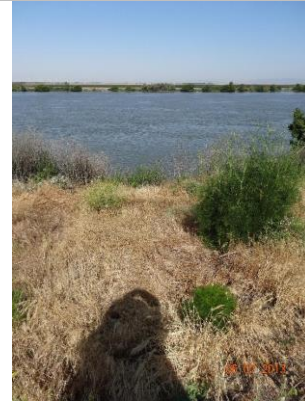
Photo 1 of 3 : UCIP\_SP\_2019\_53353\_58967.jpg

Comment Code					
Inspector Comment					
FS_ID:53353 DS_ID:21092 EP_NO: 3703 Repair Type: Urgent Crossing Status: Found UCIP Comments: 07/24/2018 Same as last inspection. Could not inspect WS due to overgrown vegetation. Keeping Urgent due to pipe integrity concerns and threat to levee integrity (D. Sanoski - DWR UCIP).8/22/2016 Same as last inspection -- pipe is deteriorating and breaking apart (visible on WS). (DWR UCIP - omagana)6/07/2013 Deteriorated pipe with holes present at intake. Dense vegetation limits the inspector's visibility to identify signs of pipe failure (leaks) through the slope. Recommend removing vegetation along pipe alignment to conduct proper inspection of structure and appurtenances. If crossing is no longer used --owner will need coordinate with CVFPB to address crossing. Need to coordinate with DWR Inspector and CVFPB. (DWR UCIP - omagana) FIELD_STRUCT_DESC: *ABANDONED* 8-inch steel irrigation siphon pipe through the levee, 1.7 feet below the crown. Siphon breaker on the apex of the pipe on the landside (LS) shoulder. Pipe discharges into a concrete sump near the LS toe. Pipe is exposed along the LS slope. Second 8-inch pipe approximately 1 foot apart is visible on the LS. Pipe is also visible on the waterside (WS). (Retention of an existing 8-inch siphon pipe through the levee authorized under Permit No. 3703, 1961 - Enzo Guidi). [Additional Reference(s): DWR Levee Log, 2005]. FS Date: 7/24/2018 3:43:00 PM

Overview of WS--20 foot berm present.

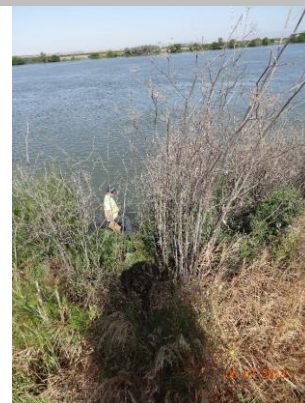
Photo 2 of 3 : UCIP\_SP\_2019\_53353\_58965.jpg

View of WS. Inspector is standing near exposed section of pipe at levee toe.

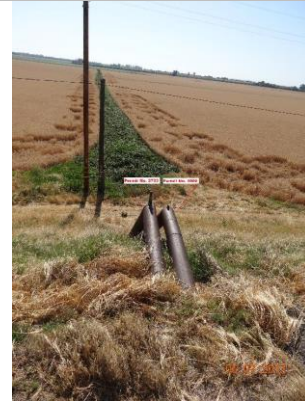
Photo 1 of 3 : UCIP\_SP\_2019\_53354\_58968.jpg

Comment Code						
Inspector Comment						
FS_ID:53354 DS_ID:21036 EP_NO: 1902 Repair Type: Urgent Crossing Status: Found UCIP Comments: 07/24/2018 Same as last inspection. Could not inspect WS due to overgrown vegetation. Keeping Urgent due to pipe integrity concerns and threat to levee integrity (D. Sanoski - DWR UCIP).8/22/2016 Same as previous inspection. Pipe is deteriorating and open on WS. (DWR UCIP - omagana)6/07/2013 Reason for an Urgent Priority is due to adjacent crossing--adjacent crossing has holes present and is was installed in the 1960s. Our records show this pipe was installed before 1955. Dense vegetation limits the inspector's visibility to identify signs of pipe failure (leaks) through the slope. Recommend removing vegetation along pipe alignment to conduct proper inspection of structure and appurtenances. If crossing is no longer in use--Owner will need to coordinate with DWR Inspector and CVFPB. Need to determine condition of pipe--request maintenance records from owner once found-this crossing could be capped and grouted--NEED RECORDS. (DWR UCIP - omagana) FIELD_STRUCT_DESC: *ABANDONED* 8-inch steel irrigation siphon pipe encased in a 10-inch, 14 gage corrugated metal pipe (CMP) through the levee, 1.7 feet below the crown. Siphon breaker on the apex of the pipe on the landside (LS) shoulder. Pipe discharges into a concrete sump near the LS toe. Pipe exposed along the LS slope. (Plans for replacing an existing pipe through the levee authorized under Permit No. 1902, 1954 - Enzo Guidi). [Additional Reference(s): DWR Levee Log, 2005. USACE Sacramento O&M Manual 105, April 1959, (HLM 0.9)]. FS Date: 7/24/2018 3:36:00 PM

8-inch pipes approximately 1 foot apart.

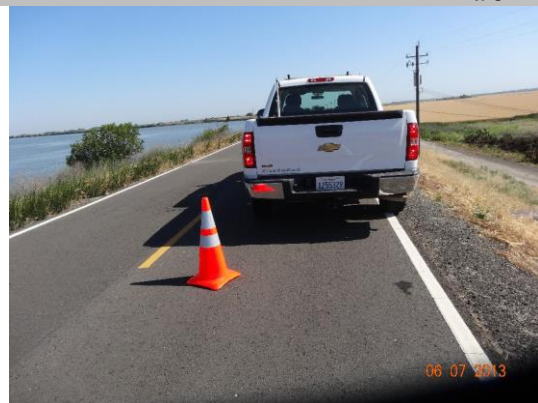
Photo 1 of 3 : UCIP\_SP\_2019\_44865\_58975.jpg

Comment Code						
Inspector Comment						
FS_ID:44865 DS_ID:21038 EP_NO: 2817 Repair Type: Non-Urgent Crossing Status: Found UCIP Comments: Dense vegetation limits the inspector's visibility to identify signs of pipe failure (leaks) through the slope. Recommend removing vegetation along pipe alignment to conduct proper inspection of structure and appurtenances. Scour hole located on waterward side. FIELD_STRUCT_DESC: 20-inch steel drainage discharge pipe sleeved through a 24-inch steel pipe through the levee, 9 feet below the crown. Flap gate on the waterside (WS) end. Cutoff wall around the pipe at each shoulder. Pipe exposed along both slopes. Rock revetment on the WS slope. Berm on the WS is over 20 feet. (Plans to install a drainage pipe through the levee authorized under Permit No. 2817, 1958 - Reclamation District No. 501 [RD0501]). [Additional Reference(s): DWR Levee Log, 2005]. FS Date: 6/7/2013

View of levee crown at crossings.

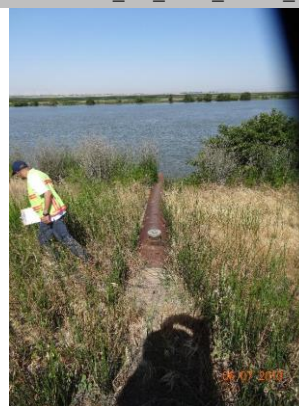
Photo 2 of 3 : UCIP\_SP\_2019\_44865\_58972.jpg

Comment Code						
Inspector Comment						
FS_ID:44865 DS_ID:21038 EP_NO: 2817 Repair Type: Non-Urgent Crossing Status: Found UCIP Comments: Dense vegetation limits the inspector's visibility to identify signs of pipe failure (leaks) through the slope. Recommend removing vegetation along pipe alignment to conduct proper inspection of structure and appurtenances. Scour hole located on waterward side. FIELD_STRUCT_DESC: 20-inch steel drainage discharge pipe sleeved through a 24-inch steel pipe through the levee, 9 feet below the crown. Flap gate on the waterside (WS) end. Cutoff wall around the pipe at each shoulder. Pipe exposed along both slopes. Rock revetment on the WS slope. Berm on the WS is over 20 feet. (Plans to install a drainage pipe through the levee authorized under Permit No. 2817, 1958 - Reclamation District No. 501 [RD0501]). [Additional Reference(s): DWR Levee Log, 2005]. FS Date: 6/7/2013

View of waterward side--pipe section exposed and siphon breaker. Over 20 feet berm on waterward side.

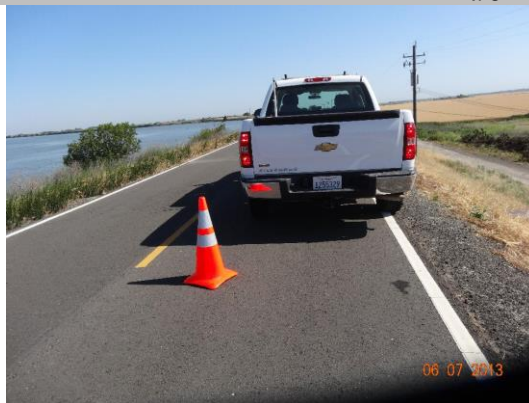
Photo 1 of 3 : UCIP\_SP\_2019\_44866\_58981.jpg

Comment Code					
Inspector Comment					
FS_ID:44866 DS_ID:21094 EP_NO: 14491 Repair Type: Non-Urgent Crossing Status: Found UCIP Comments: Dense vegetation limits the inspector's visibility to identify signs of pipe failure (leaks) through the slope. Recommend removing vegetation along pipe alignment to conduct proper inspection of structure and appurtenances. Scour hole present on waterward side. FIELD_STRUCT_DESC: 24-inch coated steel drainage discharge pipe through the levee, 4.5 feet below the crown. Cutoff wall around the pipe at the center of the levee. Siphon breaker on the apex of the pipe at the waterside (WS) shoulder. Pump on the landside (LS). (Plans to install a 24-inch water discharge pipe through the levee authorized under Permit No. 14491, 1986 - Reclamation District No. 501 [RD0501]). FS Date: 6/7/2013

View of downstream crown.

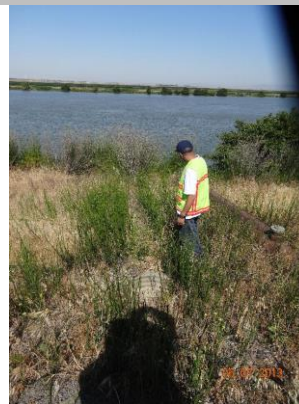
Photo 2 of 3 : UCIP\_SP\_2019\_44866\_58979.jpg

LM Start	<b>1.16</b>	Rating **	M	Issue No.	<b>30 (cont)</b>
LM End	<b>1.16</b>	Issue Type +	En	Location *

Two pipes on waterside.

Comment Code						
Inspector Comment						
FS_ID:44866 DS_ID:21094 EP_NO: 14491 Repair Type: Non-Urgent Crossing Status: Found UCIP Comments: Dense vegetation limits the inspector's visibility to identify signs of pipe failure (leaks) through the slope. Recommend removing vegetation along pipe alignment to conduct proper inspection of structure and appurtenances. Scour hole present on waterward side. FIELD_STRUCT_DESC: 24-inch coated steel drainage discharge pipe through the levee, 4.5 feet below the crown. Cutoff wall around the pipe at the center of the levee. Siphon breaker on the apex of the pipe at the waterside (WS) shoulder. Pump on the landside (LS). (Plans to install a 24-inch water discharge pipe through the levee authorized under Permit No. 14491, 1986 - Reclamation District No. 501 [RD0501]). FS Date: 6/7/2013

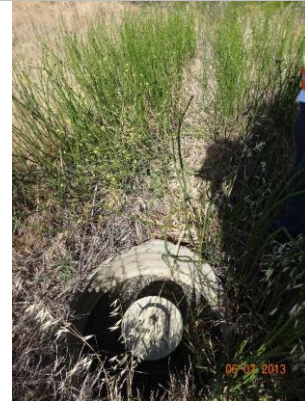
Photo 3 of 3 : UCIP\_SP\_2019\_44866\_58976.jpg

Siphon breaker located at the waterward shoulder.

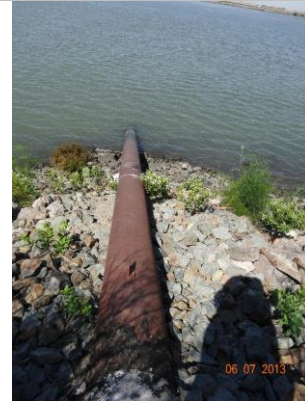
Photo 3 of 3 : UCIP\_SP\_2019\_44867\_58985.jpg

Comment Code					
Inspector Comment					
FS_ID:44867 DS_ID:21093 EP_NO: 13520 Repair Type: Non-Urgent Crossing Status: Found UCIP Comments: Dense vegetation limits the inspector's visibility to identify signs of pipe failure (leaks) through the slope. Recommend removing vegetation along pipe alignment to conduct proper inspection of structure and appurtenances. Owner needs to be informed about the vegetation clearance required for proper inspection. FIELD_STRUCT_DESC: 18-inch coated steel irrigation siphon pipe through the levee, 3.4 feet below the crown. Steel cutoff wall around the pipe at the center of the levee. Siphon breaker on the apex of the pipe on the landside (LS) shoulder. Pipe extends from a sump off the LS toe. Pipe exposed along the waterside (WS) slope. Rock revetment on the WS slope. (Plans to remove two siphons and install one 18-inch steel siphon through the levee authorized under Permit No. 13520, 1982 - Lewis Nixon Company). FS Date: 6/7/2013

Photo of pipe looking from berm edge to river edge.

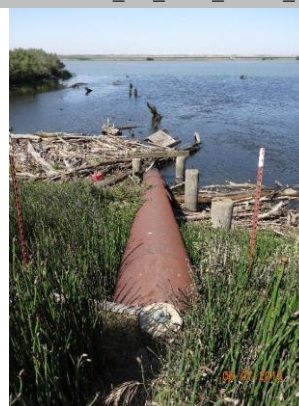
Photo 3 of 3 : UCIP\_SP\_2019\_40489\_33357.jpg

Item	DWR UCIP Field Study		38.208874 °	38.208874 °	
			-121.655505 °	-121.655505 °	
DWR ID	21042				
Comment Code					
Inspector Comment					
FS_ID:40489 DS_ID:21042 EP_NO: 15477 Repair Type: Non-Urgent Crossing Status: Found UCIP Comments: Stacey Boyd, LMA superintendent for RD0501, confirmed the removal and replacement of existing crossing under new permit no. 18811. New crossing will be a 30-inch diameter discharge pipe above the design flood plane. Construction will start soon. Update record once the project is completed. Dense vegetation on both waterside and landside. Recommend removing vegetation along pipe alignment to conduct proper inspection of structure and appurtenances. FIELD_STRUCT_DESC: 42-inch steel drainage discharge pipe through the levee, 6.5 feet below the crown. Siphon breaker on the waterside (WS) slope. Pump on the landside (LS). Pipe exposed along both slopes. (Plans to replace two pipes with two 36-inch discharge pipes through the levee authorized under Permit No. 15477, 1990 - Reclamation District No. 501 [RD0501]). Permit does not match this crossing. Recommend deletion of permit. [Additional Reference(s): DWR Levee Log, 2005. USACE Sacramento O&M Manual 105, April 1959, (HLM 2.0)]. FS Date: 6/7/2013

Siphon breaker on apex of steel pipe waterside.

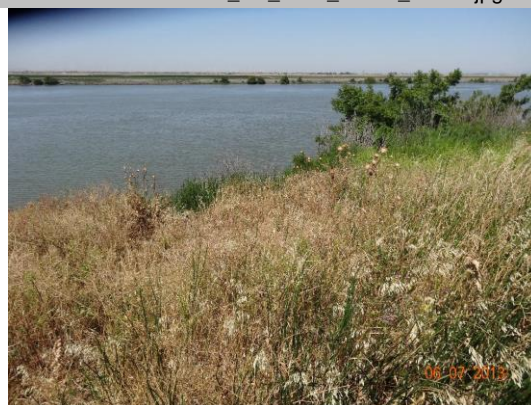
Photo 2 of 3 : UCIP\_SP\_2019\_32537\_58990.jpg

Comment Code					
Inspector Comment					
FS_ID:32537 DS_ID:21044 EP_NO: N/A Repair Type: Non-Urgent Crossing Status: Found UCIP Comments: Dense vegetation limits the inspector's visibility to identify signs of pipe failure (leaks) through the slope. Recommend removing vegetation along pipe alignment to conduct proper inspection of structure and appurtenances. FIELD_STRUCT_DESC: 14-inch coated steel irrigation siphon pipe through the levee, 6.2 feet below the crown. Siphon breaker on the waterside (WS) shoulder. (Plans to replace a section of an existing 14-inch pipe in the levee authorized under Permit No. 13937, 19 - Lewis Nixon Company). [Additional Reference(s): DWR Levee Log, 2005. USACE Sacramento O&M Manual 105, April 1959, (HLM 2.6)]. FS Date: 6/7/2013

LM Start	<b>2.44</b>	Rating **	M	Issue No.	<b>36 (cont)</b>
LM End	<b>2.44</b>	Issue Type +	En	Location *

Photo taken just downstream of crossing looking at waterward side.

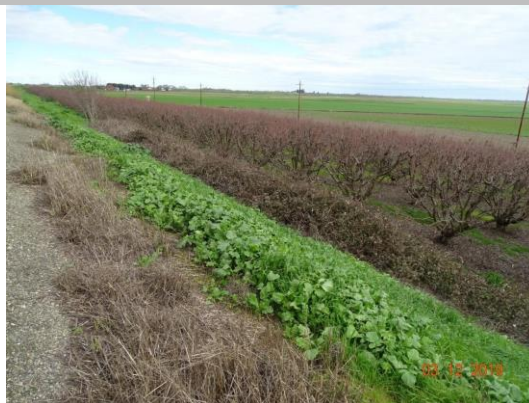
Photo 1 of 1 : SP\_2019\_RD0501\_170\_25\_20190314\_00046.jpg

LM Start	2.64	Rating **	M	Issue No.	25
LM End	2.64	Issue Type +	Ma	Location *	LS
Category	Earthen Levee			GPS Latitude/Longitude	
				Start	End
Item	Vegetation			38.215720 °	38.215720 °
				-121.667430 °	-121.667430 °
DWR ID	DWR_RD0501_02_s_2019_25				
Comment Code					
V2 : Remove the wild growth other than native grasses from the levee slopes.					
Inspector Comment					
Remove blackberries from bottom of levee slope.

View of blackberries at the landside toe (Spring 2019).

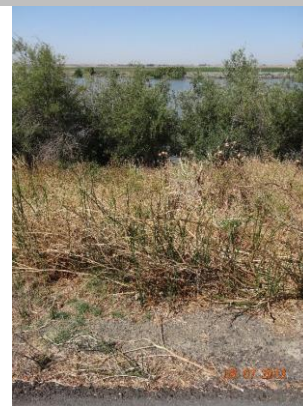
Photo 1 of 3 : UCIP\_SP\_2019\_19657\_33396.jpg

LM Start	3.07	Rating **	M	Issue No.	38	
LM End	3.07	Issue Type +	En	Location *		
Category	Supplemental			GPS Latitude/Longitude		
				Start	End	
Item	DWR UCIP Field Study			38.221090 °	38.221090 °	
				-121.671384 °	-121.671384 °	
DWR ID	21046

Comment Code						
Inspector Comment						
FS_ID:19657 DS_ID:21046 EP_NO: N/A Repair Type: Non-Urgent Crossing Status: Found UCIP Comments: Dense vegetation limits the inspector's visibility to identify signs of pipe failure (leaks) through the waterward slope. Recommend removing vegetation along pipe alignment to conduct proper inspection of structure and appurtenances. FIELD_STRUCT_DESC: 16-inch welded steel irrigation siphon pipe sleeved through a 20-inch coated steel pipe through the levee, 4.7 feet below the crown. Annular space grouted. Siphon breaker on the landside (LS) shoulder. Pipe exposed along both slopes. (Plans to place a new 16-inch welded steel pipe within the old 20-inch siphon authorized under Permit No. 2645, 1957 - Henry and Joseph Passaglia). [Additional Reference(s): DWR Levee Log, 2005. USACE Sacramento O&M Manual 105, April 1959, (HLM 3.3)]. FS Date: 8/22/2013

Dense vegetation along the crown hinge point and beginning section of waterward slope.

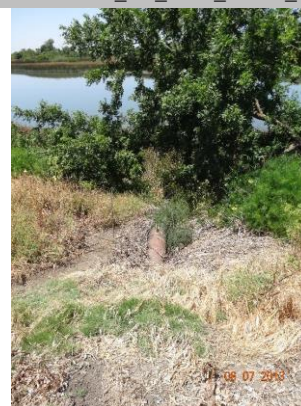
Photo 1 of 3 : UCIP\_SP\_2019\_44873\_33405.jpg

Comment Code					
Inspector Comment					
FS_ID:44873 DS_ID:21065 EP_NO: N/A Repair Type: Non-Urgent Crossing Status: Found UCIP Comments: Pump operating during inspection. Need to determine owner. Dense vegetation limits the inspector's visibility to identify signs of pipe failure (leaks) through the waterward slope. Recommend removing vegetation along pipe alignment to conduct proper inspection of structure and appurtenances. FIELD_STRUCT_DESC: 14-inch steel irrigation discharge pipe through the levee, 6.3 feet below the crown. Siphon breaker on the landside (LS) slope. Pipe exposed on both slopes. [Additional Reference(s): DWR Levee Log, 2005. USACE Sacramento O&M Manual 105, April 1959, (HLM 0.7), 16-inch pipe referenced]. FS Date: 6/7/2013

Overview of waterward side. Dense vegetation limits proper inspection.

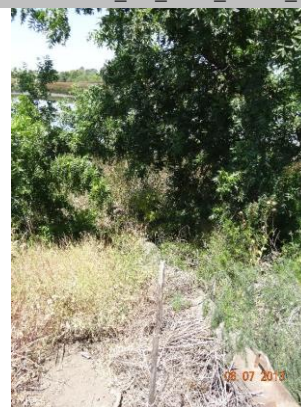
Photo 2 of 3 : UCIP\_SP\_2019\_44873\_33402.jpg

LM Start	<b>0.62</b>	Rating **	M	Issue No.	<b>51 (cont)</b>
LM End	<b>0.62</b>	Issue Type +	En	Location *

Conditions of waterward slope--dense vegetation along slope.

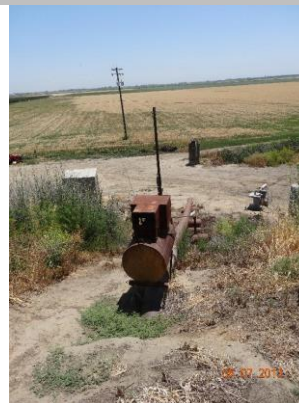
Photo 3 of 3 : UCIP\_SP\_2019\_44873\_33404.jpg

Comment Code						
Inspector Comment						
FS_ID:44873 DS_ID:21065 EP_NO: N/A Repair Type: Non-Urgent Crossing Status: Found UCIP Comments: Pump operating during inspection. Need to determine owner. Dense vegetation limits the inspector's visibility to identify signs of pipe failure (leaks) through the waterward slope. Recommend removing vegetation along pipe alignment to conduct proper inspection of structure and appurtenances. FIELD_STRUCT_DESC: 14-inch steel irrigation discharge pipe through the levee, 6.3 feet below the crown. Siphon breaker on the landside (LS) slope. Pipe exposed on both slopes. [Additional Reference(s): DWR Levee Log, 2005. USACE Sacramento O&M Manual 105, April 1959, (HLM 0.7), 16-inch pipe referenced]. FS Date: 6/7/2013

Overview of landward side--pump system, pipe, and standpipe.

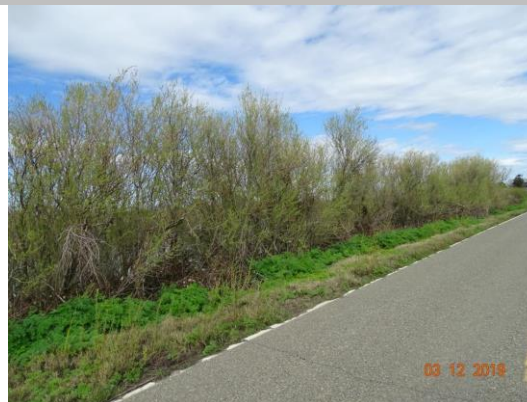
Photo 1 of 1 : SP\_2019\_RD0501\_171\_30\_20190314\_00082.jpg

LM Start	0.78	Rating **	U	Issue No.	30
LM End	0.93	Issue Type +	Ma	Location *	WS
Category	Earthen Levee			GPS Latitude/Longitude	
				Start	End
Item	Vegetation			38.236968 °	38.239040 °
				-121.665088 °	-121.664862 °
DWR ID	DWR_RD0501_03_s_2019_30				
Comment Code					
V2 : Remove the wild growth other than native grasses from the levee slopes.					
Inspector Comment					
Remove willows and blackberries 20' from crown.

View looking upstream at vegetation on the waterside slope (Spring 2019).

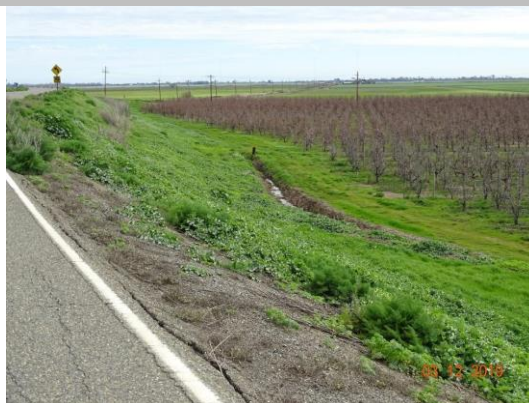
Photo 1 of 1 : SP\_2019\_RD0501\_171\_33\_20190314\_00083.jpg

LM Start	1.21	Rating **	M	Issue No.	33
LM End	1.33	Issue Type +	En	Location *	LS
Category	Earthen Levee			GPS Latitude/Longitude	
				Start	End
Item	Encroachments			38.242103 °	38.242805 °
				-121.661745 °	-121.659637 °
DWR ID	DWR_RD0501_03_s_2019_33				
Comment Code					
DT : Ditch					
Inspector Comment					
Ditch located at landside toe.

View looking upstream at ditch on the landside toe (Spring 2019).

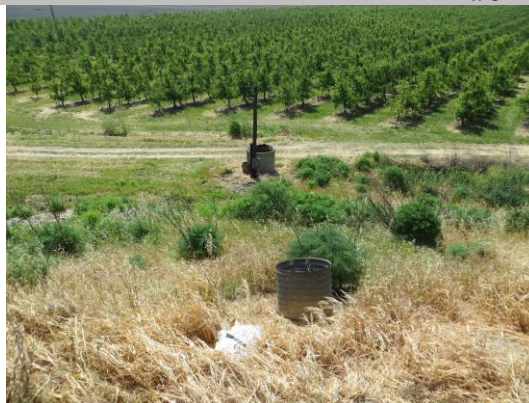
Photo 1 of 2 : UCIP\_SP\_2019\_44728\_73924.jpg

Comment Code					
Inspector Comment					
FS_ID:44728 DS_ID:21066 EP_NO: N/A Repair Type: Non-Urgent Crossing Status: Found UCIP Comments: Pipe appears abandoned and if so should be done so properly. Wooden walkway to pier in disrepair and a hazard. FIELD_STRUCT_DESC: 12-inch steel irrigation discharge pipe through the levee, 8 feet below the crown. Siphon breaker on the landside (LS) slope. Pump on a pipe structure in the stream. Concrete standpipe and distribution slide gates at the LS toe. 1.5-inch electrical conduit at the same location. [Additional Reference(s): DWR Levee Log, 2005. USACE Sacramento O&M Manual 105, April 1959, (HLM 1.5)]. FS Date: 6/7/2013

Siphon breaker in 24-inch CMP riser on LS slope. Standpipe visible at LS toe.

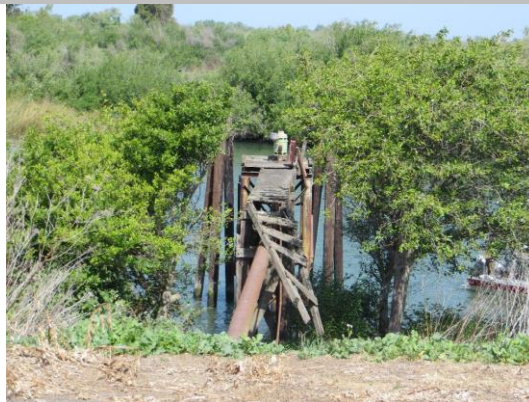
Photo 2 of 2 : UCIP\_SP\_2019\_44728\_73923.jpg

LM Start	1.35	Rating **	M	Issue No.	52 (cont)
LM End	1.35	Issue Type +	En	Location *

Pump on wooden pier off WS toe.

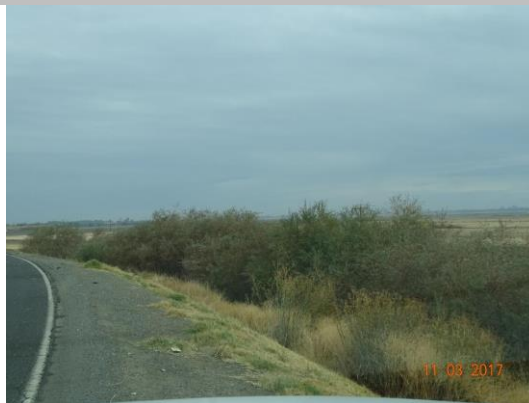
Photo 1 of 1 : SP\_2019\_RD0501\_171\_28\_20190311\_00001.jpg

LM Start	1.48	Rating **	M	Issue No.	28	
LM End	1.48	Issue Type +	Ma	Location *	LS	
Category	Earthen Levee			GPS Latitude/Longitude		
				Start		End
Item	Trim / Thin Trees			38.244293 °		38.244293 °
				-121.657843 °		-121.657843 °
DWR ID	DWR_RD0501_03_f_2017_28					
Comment Code						
T2 : Thin trees to allow visibility of the ground and room to flood fight.						
Inspector Comment						
Trim/thin willows to allow inspection and access to landside slope and toe.

Trim/thin willows to allow inspection and access to landside slope and toe.

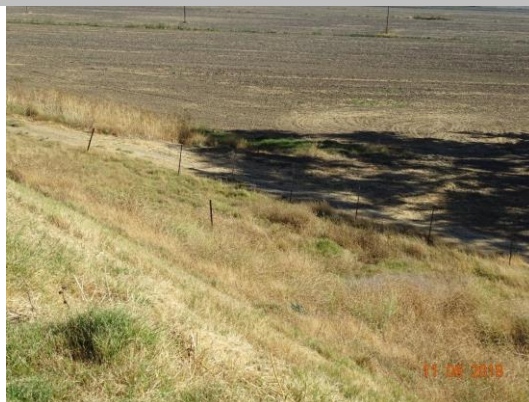
Photo 1 of 1 : SP\_2019\_RD0501\_171\_46\_20190311\_00013.jpg

LM Start	1.70	Rating **	M	Issue No.	46
LM End	1.70	Issue Type +	En	Location *	LS
Category	Earthen Levee			GPS Latitude/Longitude	
				Start	End
Item	Encroachments			38.247218 °	38.247218 °
				-121.658217 °	-121.658217 °
DWR ID	DWR_RD0501_03_f_2018_46				
Comment Code					
FE : Fence					
Inspector Comment					
Fence located on landside toe does not have permit.

View of unpermitted fence on the landside toe (November 2018).

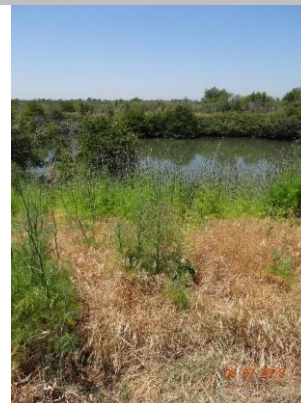
Photo 1 of 2 : UCIP\_SP\_2019\_43503\_33410.jpg

Comment Code					
Inspector Comment					
FS_ID:43503 DS_ID:21068 EP_NO: N/A Repair Type: Non-Urgent Crossing Status: Found UCIP Comments: Authorized or Unauthorized? Need permit authorizing work. Dense vegetation limits the inspector's visibility to identify signs of pipe failure (leaks) through the slope on both waterward and landward side. Recommend removing vegetation along pipe alignment to conduct proper inspection of structure and appurtenances. FIELD_STRUCT_DESC: 10-inch steel irrigation discharge pipe through the levee, 6.3 feet below the crown. Pump, gate valve, and switch box on the waterside (WS) slope. [Additional Reference(s): DWR Levee Log, 2005. USACE Sacramento O&M Manual 105, April 1959, (HLM 2.0), reported as 3.8 feet below the crown]. FS Date: 6/7/2013

Overview of waterward side. Pipe is completely obstructed by dense vegetation.

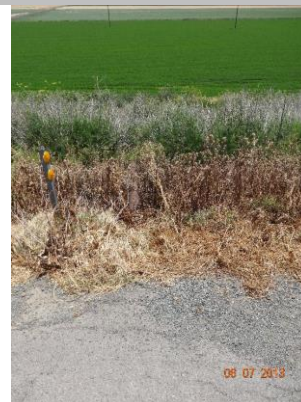
Photo 2 of 2 : UCIP\_SP\_2019\_43503\_33411.jpg

Overview of landward side. Pipe is visible however dense vegetation limits proper inspection.

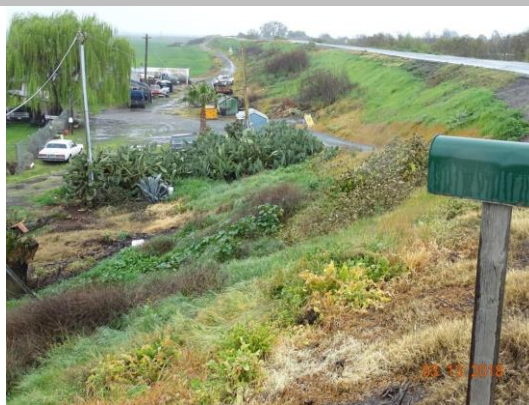
Photo 2 of 2 : SP\_2019\_RD0501\_171\_31\_20190311\_00004.jpg

Cactus at toe should be removed.

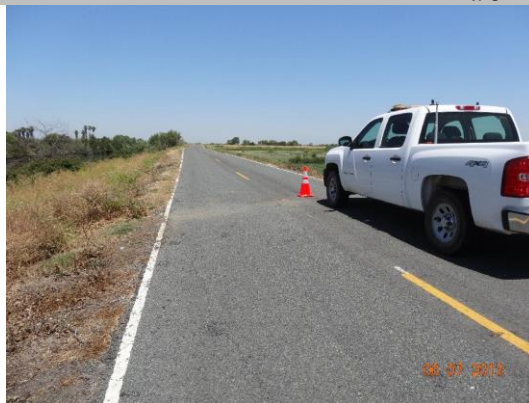
Photo 1 of 3 : UCIP\_SP\_2019\_18945\_31607.jpg

LM Start	2.52	Rating **	M	Issue No.	54
LM End	2.52	Issue Type +	En	Location *	
Category	Supplemental			GPS Latitude/Longitude	
				Start	End
Item	DWR UCIP Field Study			38.256255 °	38.256255 °
				-121.651551 °	-121.651551 °
DWR ID	21047				
Comment Code					
Inspector Comment					
FS_ID:18945 DS_ID:21047 EP_NO: N/A Repair Type: Non-Urgent Crossing Status: Found UCIP Comments: Need to determine owner of structure. Recommend removing vegetation along pipe alignment to conduct proper inspection of structure and appurtenances. FIELD_STRUCT_DESC: 16-inch steel irrigation siphon pipe through the levee, 3.3 feet below the crown. Gate valve and switch box on the landside (LS) slope. Pipe exposed on both slopes. Riprap on the waterside (WS). [Additional Reference(s): DWR Levee Log, 2005. USACE Sacramento O&M Manual 105, April 1959, (HLM 2.7)]. FS Date: 6/7/2013

Overview of levee crown at crossing.

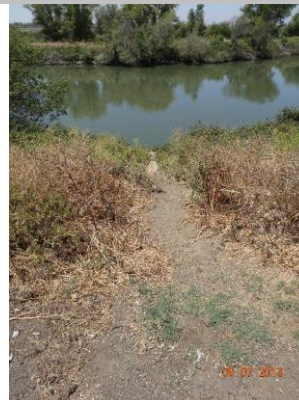
Photo 2 of 3 : UCIP\_SP\_2019\_18945\_31609.jpg

Overview of waterward side. Pipe is mostly buried through waterward side.

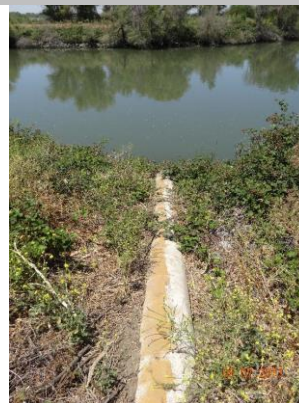
Photo 3 of 3 : UCIP\_SP\_2019\_18945\_31608.jpg

LM Start	2.52	Rating **	M	Issue No.	54 (cont)	
LM End	2.52	Issue Type +	En	Location *		
Category	Supplemental			GPS Latitude/Longitude		
				Start		End
Item	DWR UCIP Field Study			38.256255 °		38.256255 °
				-121.651551 °		-121.651551 °
DWR ID	21047					
Comment Code						
Inspector Comment						
FS_ID:18945 DS_ID:21047 EP_NO: N/A Repair Type: Non-Urgent Crossing Status: Found UCIP Comments: Need to determine owner of structure. Recommend removing vegetation along pipe alignment to conduct proper inspection of structure and appurtenances. FIELD_STRUCT_DESC: 16-inch steel irrigation siphon pipe through the levee, 3.3 feet below the crown. Gate valve and switch box on the landside (LS) slope. Pipe exposed on both slopes. Riprap on the waterside (WS). [Additional Reference(s): DWR Levee Log, 2005. USACE Sacramento O&M Manual 105, April 1959, (HLM 2.7)]. FS Date: 6/7/2013

Exposed section of pipe located on waterward side.

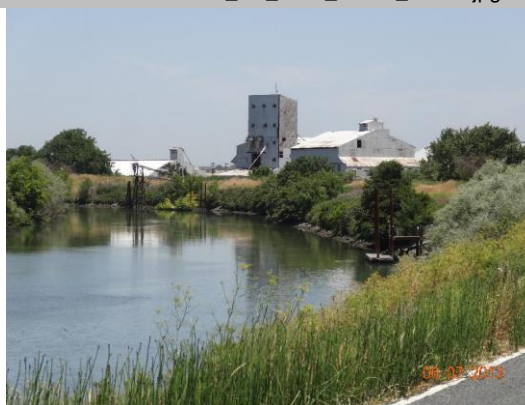
Photo 1 of 3 : UCIP\_SP\_2019\_32538\_58994.jpg

Comment Code						
Inspector Comment						
FS_ID:32538 DS_ID:21048 EP_NO: N/A Repair Type: Non-Urgent Crossing Status: Found UCIP Comments: Dense vegetation limits the inspector's visibility to identify signs of pipe failure (leaks) through the waterward slope. Recommend removing vegetation along pipe alignment to conduct proper inspection of structure and appurtenances. Need to find owner of crossing and determine if permit number is available. FIELD_STRUCT_DESC: 12-inch steel irrigation discharge pipe through the levee, 5 feet below the crown. Pump on a pile structure in the stream. Service pole on the landside (LS) slope. Concrete standpipe at the LS toe. [Additional Reference(s): DWR Levee Log, 2005. USACE Sacramento O&M Manual 105, April 1959, (HLM 3.8)]. FS Date: 6/7/2013

Photo taken downstream of structure.

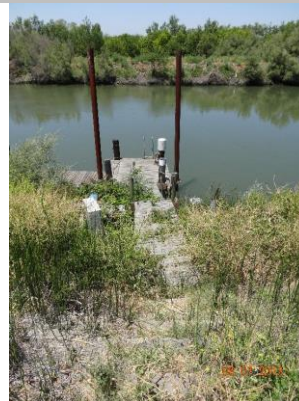
Photo 2 of 3 : UCIP\_SP\_2019\_32538\_58999.jpg

Comment Code						
Inspector Comment						
FS_ID:32538						
DS_ID:21048						
EP_NO: N/A						
Repair Type: Non-Urgent						
Crossing Status: Found						
UCIP Comments: Dense vegetation limits the inspector's visibility to identify signs of pipe failure (leaks) through the waterward slope. Recommend removing vegetation along pipe alignment to conduct proper inspection of structure and appurtenances. Need to find owner of crossing and determine if permit number is available.						
FIELD_STRUCT_DESC: 12-inch steel irrigation discharge pipe through the levee, 5 feet below the crown. Pump on a pile structure in the stream. Service pole on the landside (LS) slope. Concrete standpipe at the LS toe. [Additional Reference(s): DWR Levee Log, 2005. USACE Sacramento O&M Manual 105, April 1959, (HLM 3.8)].						
FS Date: 6/7/2013

View of waterward side. Dense vegetation throughout waterward side.  
Walkway visible and support piles.

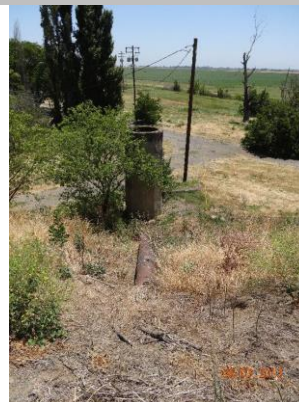
Photo 3 of 3 : UCIP\_SP\_2019\_32538\_58998.jpg

View of landward side--section of pipe exposed and Standpipe.

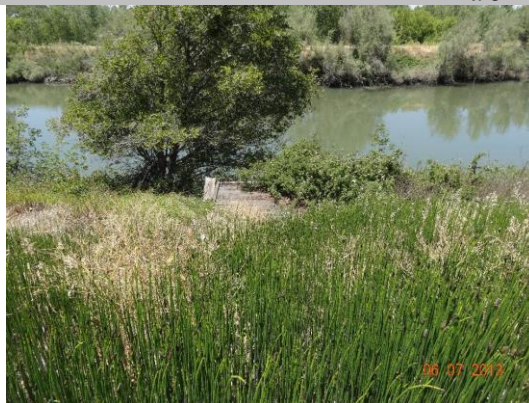
Photo 3 of 3 : UCIP\_SP\_2019\_46768\_30380.jpg

Comment Code						
Inspector Comment						
FS_ID:46768 DS_ID:21049 EP_NO: 1557 Repair Type: Non-Urgent Crossing Status: Found UCIP Comments: Crossing appears abandoned--wooden platform structure appears to be abandoned on waterward side. Small hole underneath pipe on landward side--unable to determine cause (rodent/pipe leak) Need to find owner of crossing to determine status. Recommend removing vegetation along pipe alignment to conduct proper inspection of structure and appurtenances. FIELD_STRUCT_DESC: *ABANDONED* 6-inch irrigation discharge pipe of an unknown material through the levee, 2.5 feet below the crown. Pump in a pump house on the waterside (WS) slope. (Plans for the construction of two irrigation pumping plants, about 500 feet apart, and 6-inch discharge pipes through the levee authorized under Permit No. 1557, 1951 - Poultry Producers of Central California). [Additional Reference(s): DWR Levee Log, 2005. USACE Sacramento O&M Manual 105, April 1959, (HLM 3.9)]. FS Date: 6/7/2013

Overview of waterward side with limited access to structure.

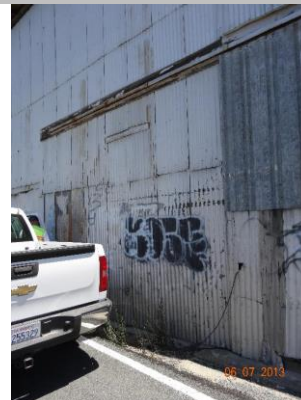
Photo 2 of 3 : UCIP\_SP\_2019\_32540\_59006.jpg

View of large building structure located on landward side.

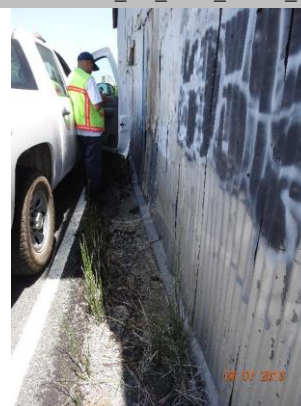
Photo 3 of 3 : UCIP\_SP\_2019\_32540\_59003.jpg

Item	DWR UCIP Field Study		38.267818 °	38.267818 °	
			-121.640521 °	-121.640521 °	
DWR ID	21050				
Comment Code					
Inspector Comment					
FS_ID:32540 DS_ID:21050 EP_NO: N/A Repair Type: Non-Urgent Crossing Status: Found UCIP Comments: Unable to properly inspect structure--limited access. Also unable to determine if structure is still in use. Levee logs indicate this crossing is abandoned. If structure is no longer used-how to prevent water from flowing through levee during flood season. If structure no longer in use owner will need to coordinate with CVFPB. FIELD_STRUCT_DESC: *ABANDONED* 66-inch by 66-inch reinforced concrete gravity drainage tunnel through the levee, 6.5 feet below the crown. [Additional Reference(s): DWR Levee Log, 2005]. FS Date: 6/7/2013

View of structure on landward side.

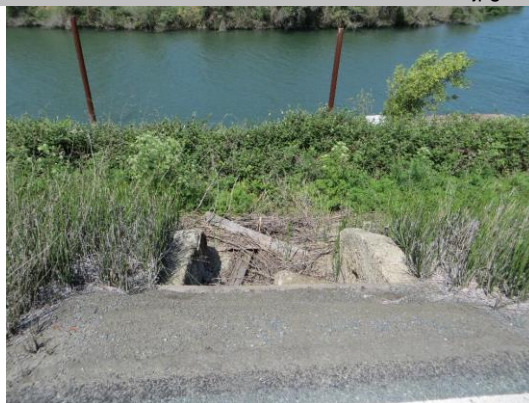
Photo 2 of 3 : UCIP\_SP\_2019\_53355\_73941.jpg

Comment Code						
Inspector Comment						
FS_ID:53355 DS_ID:21051 EP_NO: N/A Repair Type: Urgent Crossing Status: Found UCIP Comments: 07/24/2018 Same as last inspection; appears abandoned. Keeping Urgent due to levee integrity issues with open tunnel and possibility for erosion to levee (D. Sanoski - DWR UCIP).8/22/2016 Unable to locate due to high traffic area and narrow levee crown. Assume condition is same as previous inspection. CVFPB should review this crossing to determine if WS needs to be capped off for flood season. (DWR UCIP - omagana)4/23/2015 Concrete deteriorating. Pipe open on both ends. Appears abandoned and if so should be done so properly. (DWR UCIP - omagana) FIELD_STRUCT_DESC: *ABANDONED* 66-inch by 72-inch reinforced concrete drainage tunnel through the levee, 2.5 feet below the crown. [Additional Reference(s): DWR Levee Log, 2005]. FS Date: 7/24/2018 11:12:00 AM

Concrete tunnel and wingwalls visible on WS slope.

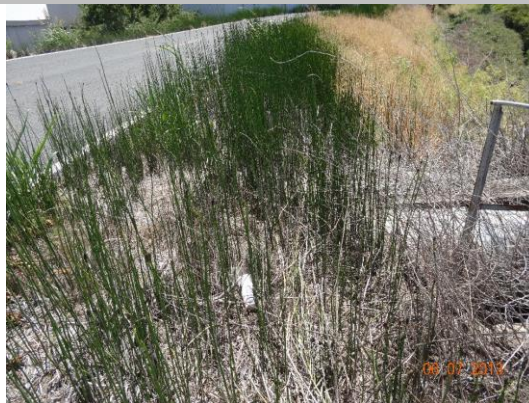
Photo 2 of 3 : UCIP\_SP\_2019\_19662\_33418.jpg

Dense vegetation along the pipe alignment and throughout waterward slope.

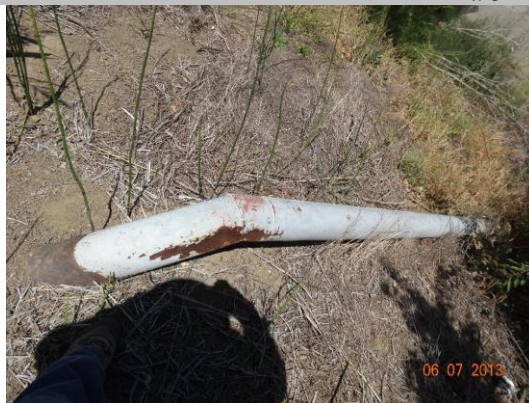
Photo 3 of 3 : UCIP\_SP\_2019\_43524\_33423.jpg

Comment Code						
Inspector Comment						
FS_ID:43524 DS_ID:21053 EP_NO: N/A Repair Type: Non-Urgent Crossing Status: Found UCIP Comments: Dense vegetation limits the inspector's visibility to identify signs of pipe failure (leaks) through the waterward slope. Recommend removing vegetation along pipe alignment to conduct proper inspection of structure and appurtenances. FIELD_STRUCT_DESC: 6-inch irrigation discharge pipe of an unknown material through the levee, 2.5 feet below the crown. Pump in a pump house on the waterside (WS) slope. (Plans for the construction of two irrigation pumping plants, about 500 feet apart, and 6-inch discharge pipes through the levee authorized under Permit No. 1557, 1951 - Poultry Producers of Central California). [Additional Reference(s): DWR Levee Log, 2005. USACE Sacramento O&M Manual 105, April 1959, (HLM 4.0)]. FS Date: 6/7/2013

Close up of pipe along landward side.
